St. Joseph Catholic Church
409 S Bridge Street, Belding, MI 48809

STAINED GLASS ASSESSMENT

January 4, 2018

Kolenda
Art Glass

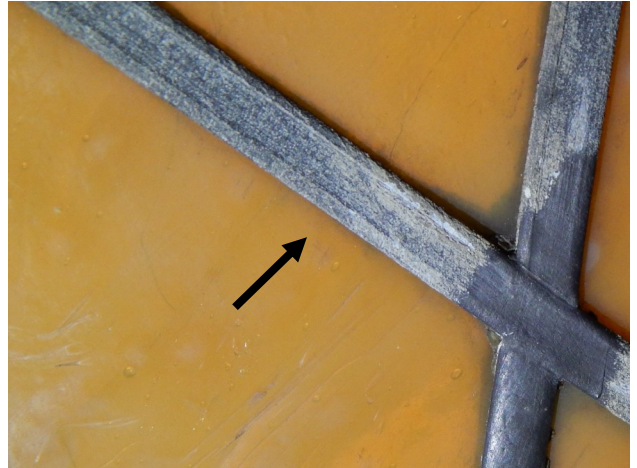
Severe oxidation can be found on the interior and exterior of the windows especially the north elevation

Remaining windows (11-21) should be cemented in situ on exterior surface to restore the water repellency and structural integrity of the leadlight cement. White oxidation on the lead should also be mechanically removed at this time to restore the naturally protective black oxide finish on the lead surface. Caulking and glazing should be replaced as needed. Cementing these windows in the near future could prolong the life of the lead matrix which will delay the need to excavate them for lead replacement.

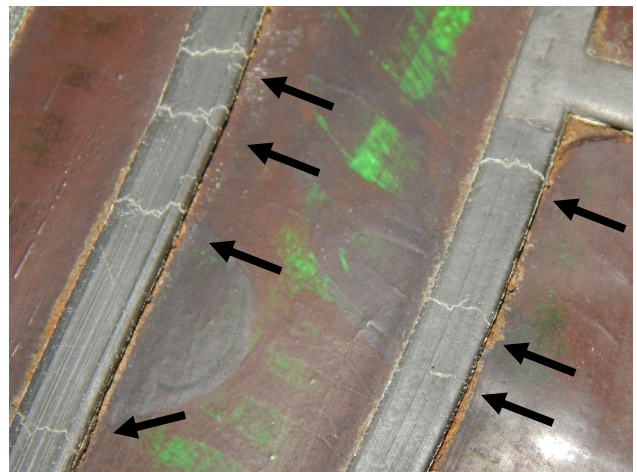
Hairline cracks in the lead matrix are widespread among the panels on the south elevation

Remove Munich windows on the south and west elevation (1-10) and replace 80-100% of lead matrix. Replacement lead should be of exact size and shape as the original and rebuilt with “tucked” joints consistent with the original construction. All fractured glass should be retained and mended with copper foil or edge glued with two part silicone. Windows should be cemented on both sides with traditional leadlight cement. Replace/restore all structural components and reinstall consistent with the original design. Currently flat, these windows could begin deflecting in the next 5-10 years potentially leading to broken glass at vulnerable hinge points.

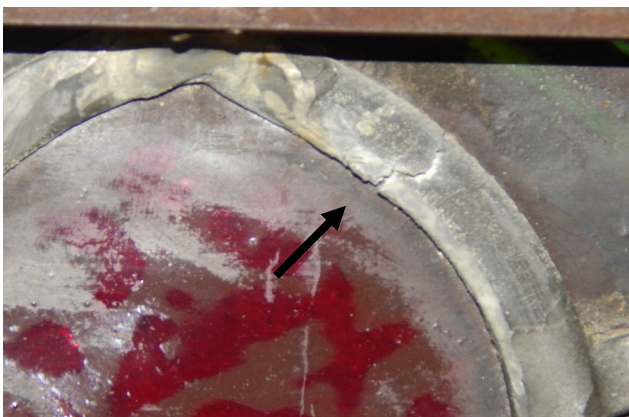
Major fractures in the lead suggest the “heart” of the channel is compromised which is the most crucial structural element of a window

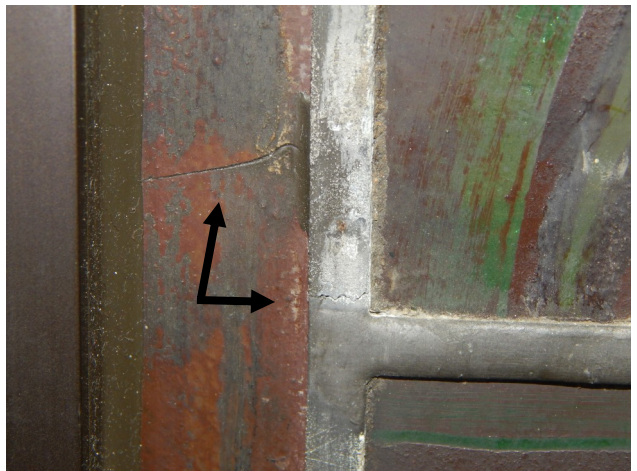
Fractured lead can create hinge points and allow excessive movement leading to broken glass

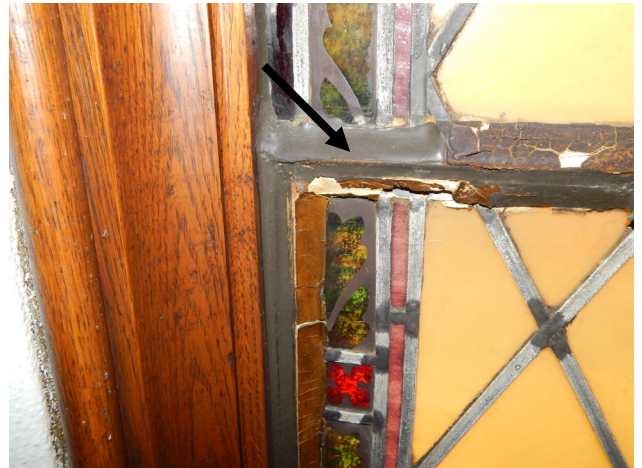
Glazing compound around vents is cracked and becoming dislodged which could allow air infiltration and movement in the stained glass

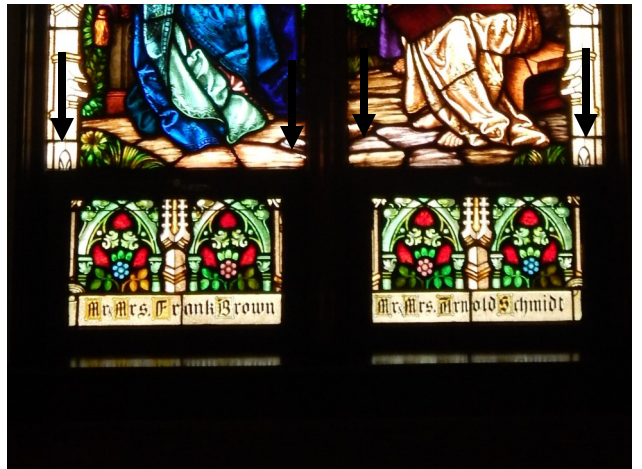
Original painted glass has been trimmed and removed to accommodate modern aluminum vent sashes,

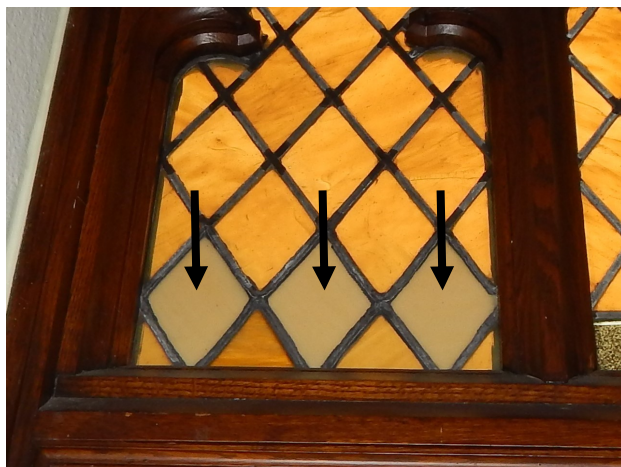
Poor replacement glass and deformed lead can be found on the narthex transom window

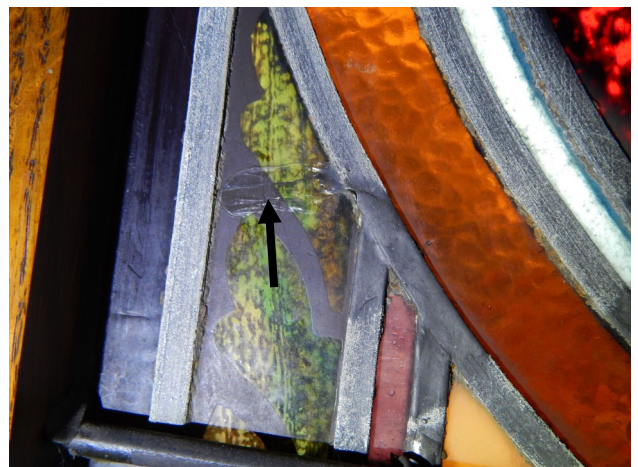
Fractured glass can be found throughout the entire collection, some with silicone smeared over top

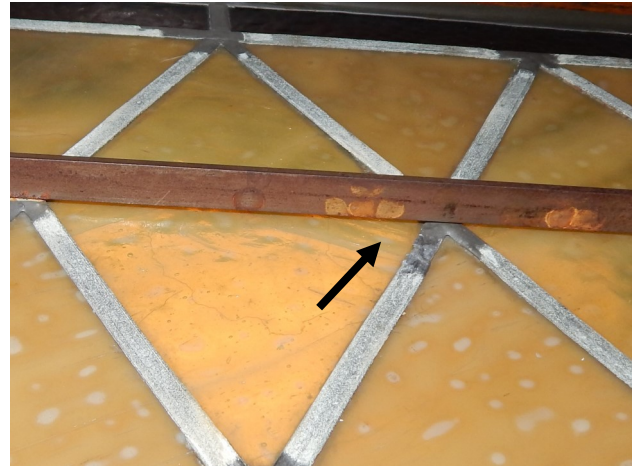
Flat bars on geometric windows are not soldered on the under side and show signs of surface rust

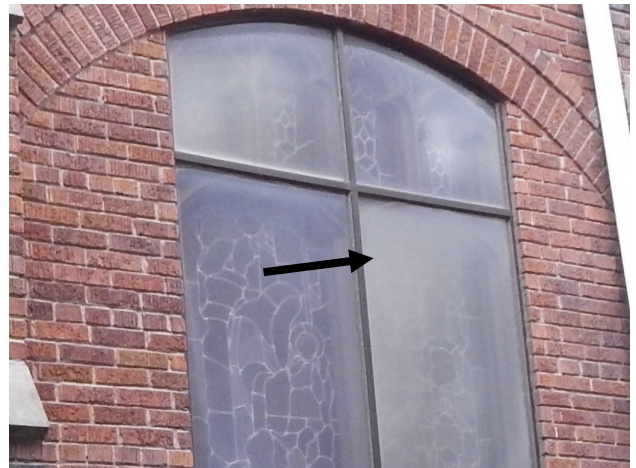
Polycarbonate sheeting clouding over which traps heat and condensation buildup

All existing polycarbonate protective glazing should be replaced with new material not prone to fogging over such as acrylic or laminated safety glass. Glazing should be properly vented top and bottom with a weep system at the bottom to allow water to escape. If new glazing material is not in the current budget the existing polycarbonate sheeting should be drilled to accept venting and weep holes in the bottom frame rail to halt the accelerated deterioration of the windows and framework.

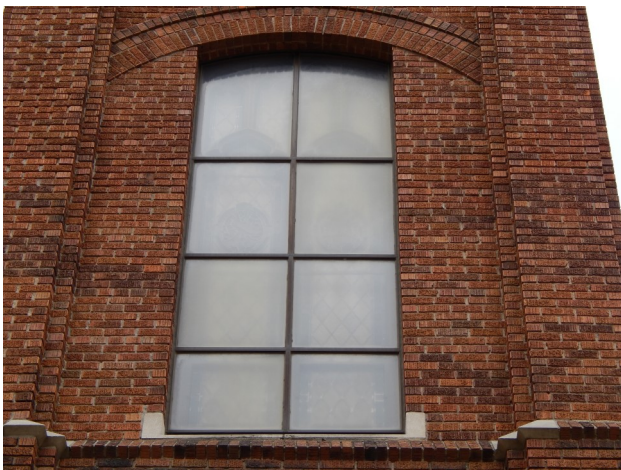
Exterior glazing has no ventilation or weep system which will trap condensation and put lateral pressure on the stained glass as the heated air space expands

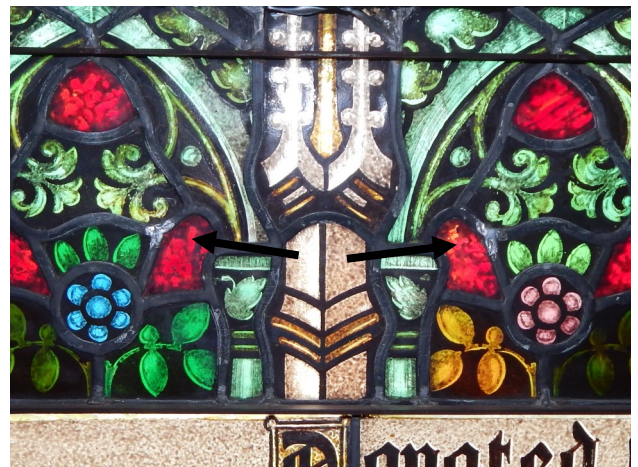
Signs of old solder joints holding the original structural supports that have been relocated
